Re: Turkey Creek
Site Visit: July 24, 2019
Civil Action 1:15-cv-16018

Region 3 Enforcement & Compliance Assurance Division
CLEAN WATER ACT SECTION 404
FIELD INVESTIGATION SUMMARY

Attachment A: Photo Log
Turkey Creek Site Visit July 24, 2019

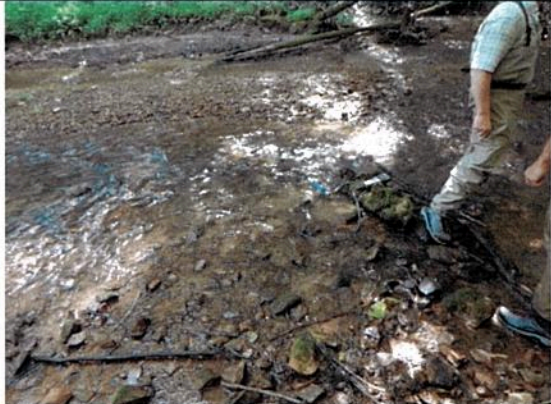
<p>Photo Id: DSCN0918.JPG Date: July 24, 2019 Photo Taken By: Katelyn Almeter</p>

Observations: Meeting location was in Union, WV. From there, USEPA followed Mr. Sams to the Site. At the Site, the inspection started at the upstream end of the Turkey Creek at point slightly upstream of the previous location of the furthest upstream dam (Dam 1) (DSCN0918.JPG). Turkey Creek was flowing at Bankfull during the time of inspection. At that location, staff from USEPA's Laboratory Service and Applied Science Division (LSASD) collected Rapid Habitat Assessment and macroinvertebrate data (DSCN0919.JPG to DSCN0922), identified as Assessment Point 1 (37.522022 N, 80.479356 W).

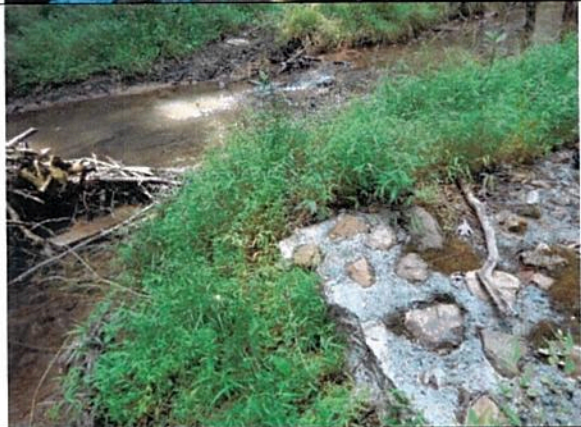
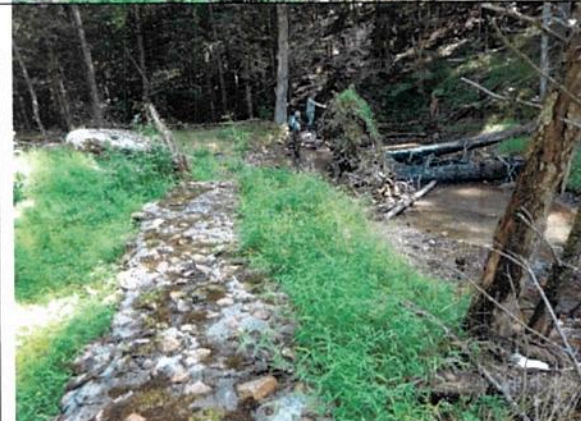
At the previous location for Dam 1, the stone wall along the bank is being left in place to preserve the current stability of that bank and avoid the bank damage that removal might pose now that vegetation has established on the stream channel side (DSCN0923.JPG and DSCN0925.JPG). The trees that had fallen across the channel while the dam was in-stream are being left in place for the quality and variety of habitat that they are currently providing (DSCN0926.JPG and DSCN0928.JPG). Even with the trees, stream flow was centered through that section of channel and not stressing the banks. The inspection continued downstream to the next dam location (DSCN0930.JPG).

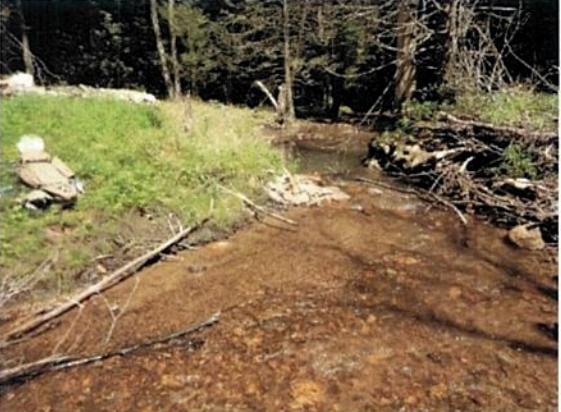
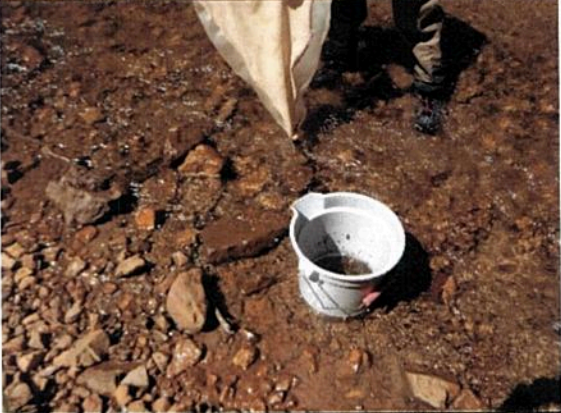
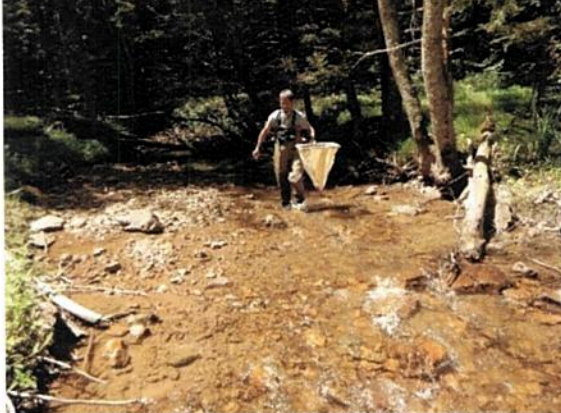
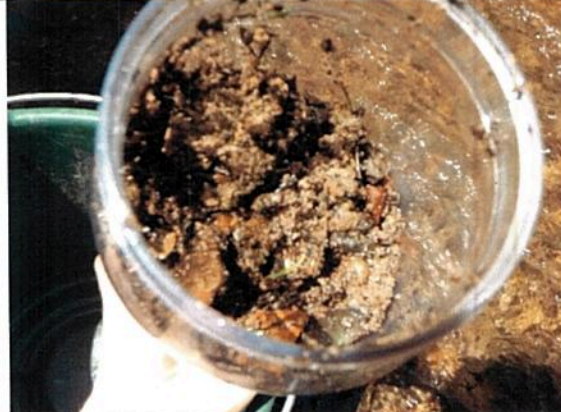
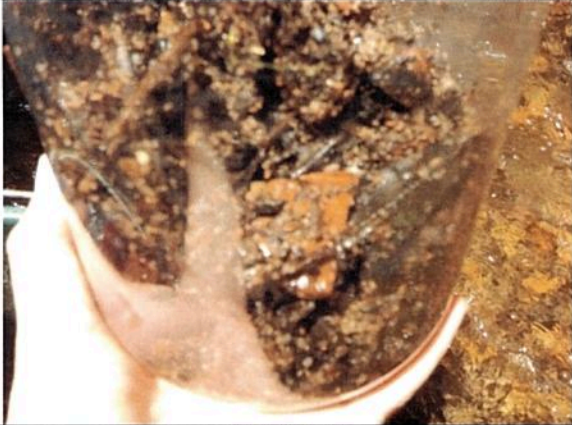
Assessment Point 2 (37.52459 N, 80.479770 W) was located at an area of riffle habitat that was previously inundated by Dam 4 (DSCN0938.JPG to DSCN0942.JPG).

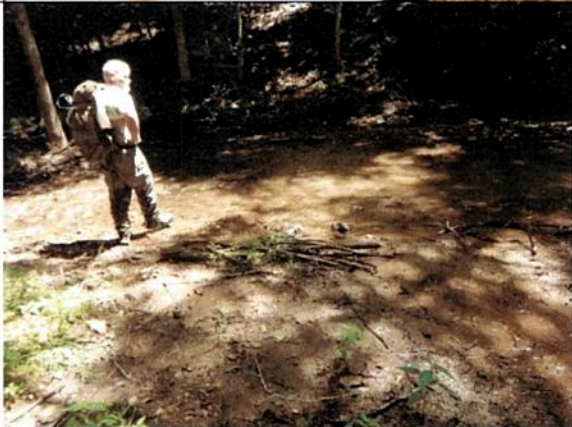
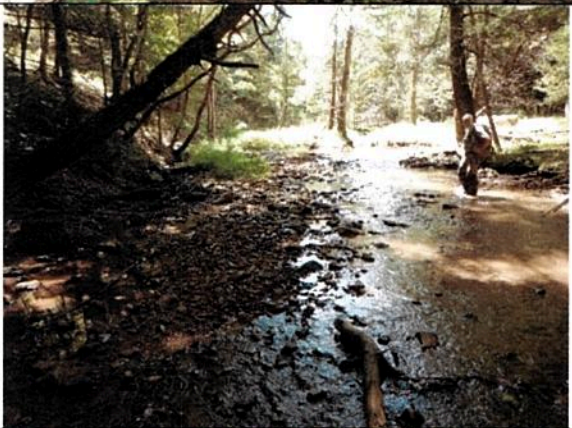
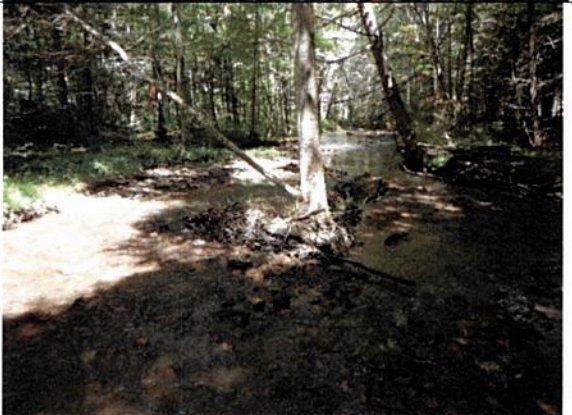
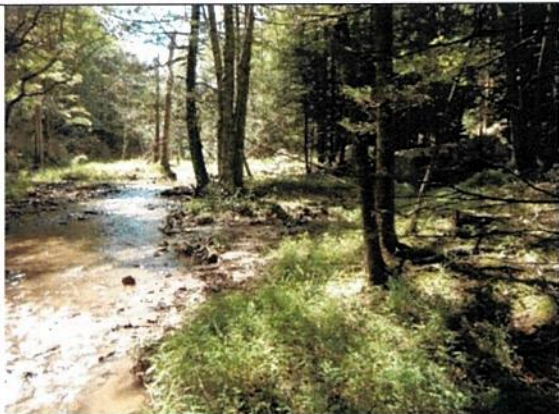
Locations of Dams 5 through 10 are in a tighter, boulder dominated valley. Drove further downstream to access the downstream locations and walked a section of Turkey Creek (DSCN0943.JPG to DSCN0946.JPG). Dam locations that previously had been identified as having damaged or eroded banks from when the dams were in place were visually checked for their current condition (DSCN0956.JPG and DSCN0957.JPG). Turkey Creek was flowing naturally and light repair work that had been completed last year appeared effective (DSCN0960.JPG). The banks have started to stabilize and revegetate (DSCN0961.JPG and DSCN0962.JPG).

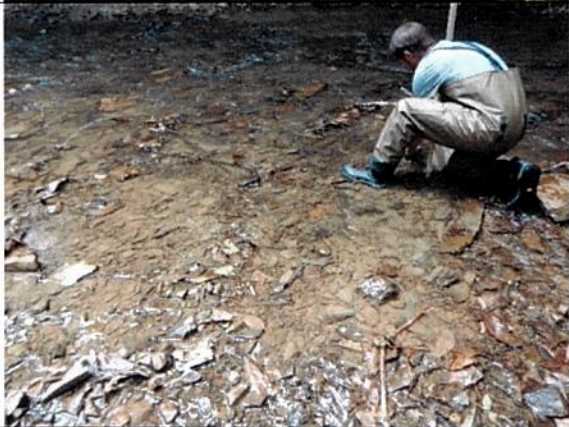
<p>Photo Id: DSCN0963.JPG Date: July 24, 2019 Photo Taken By: Katelyn Almeter</p>

Accessed the next section of dam locations downstream, which begins with Dam 11. Walked the section of Turkey Creek around Dam 12 where the side channel previously had formed by the stream flow jumping the bank to re-route around the dam. Part of the bank had been repaired and appeared to be restabilizing. Stream flow appeared centered and was flowing naturally. Assessment Point 3 (37.525815 N, 80.498850 W) was located in this area (DSCN0963.JPG).

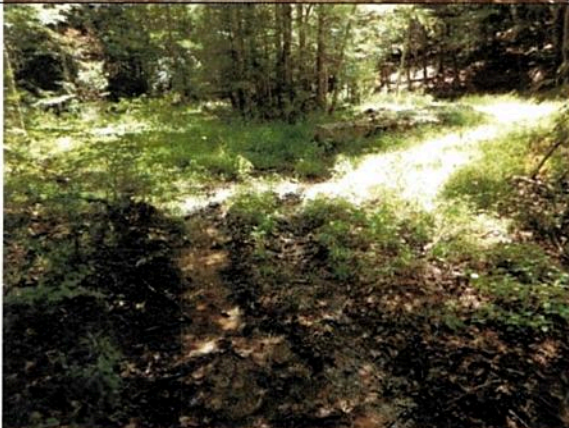
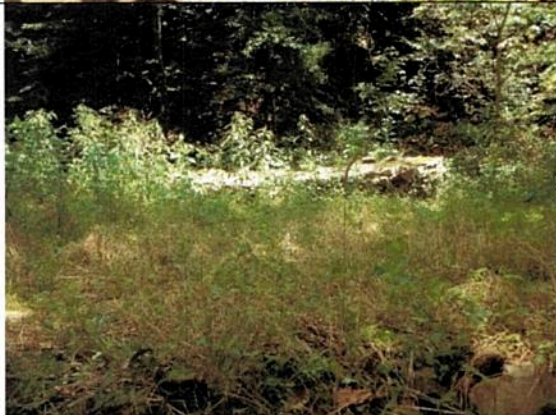
Overall, stream flows through Turkey Creek appeared to have flushed sediments throughout the Site and silts appeared reduced in the substrate. Pools created from the inundation of the dams were removed re-creating riffle habitat that was previously there. Small erosional pools along the banks at previous dam locations were still identifiable at certain locations but they were no longer actively eroding or destabilizing the stream bank and did not influence the overall character of the stream flow. At the previous dam locations, herbaceous vegetation has reestablished. The straw mulch has mostly decomposed and areas that were used for equipment access last year are mostly reclaimed. Some areas currently had better vegetative coverage than others, but all areas had at least 80% coverage (DSCN0965.JPG and DSCN0971.JPG).

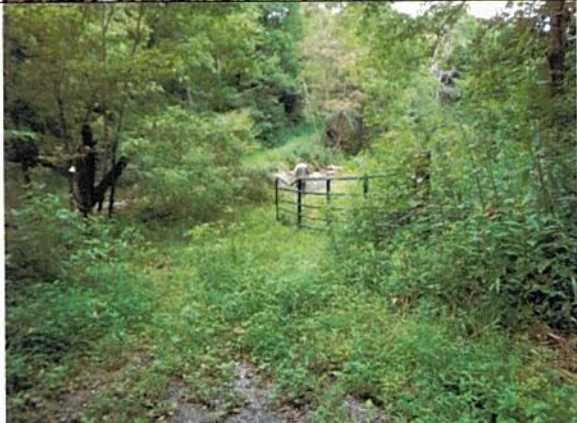
<p>Photo Id: DSCN0967.JPG Date: July 24, 2019 Photo Taken By: Katelyn Almeter</p>

The downstream three dams (Dam 18 to Dam 20) were accessed from the gate (DSCN0967.JPG). Turkey Creek appeared to be stable and flowing naturally (DSCN0969.JPG). Assessment Point 4 (37.536486 N, 80.508822 W) was located downstream of the location of Dam 20 (DSCN0973.JPG).
